Arizona Tank Divers, LLC Water Quality Specialists Earl Chitwood 928.238.0005 • Gary Chitwood 928.978.1833 aztankdivers@gmail.com

Project Loc	ation:	Pine,Az. 30	00k Elevation:		Dive Time:	4 Hrs:
TANK DETA	AILS		INSPECTIO	N REPORT		
Inspector:_	Earl Chitw	ood, Gary C	hitwood, Jeb Beyers, Ra	ndy Lance	Inspection Date:	Nov. 1 2012
Tank Capac	i ty:	<u>300K</u>	_ Tank Style:		Construction Date:	Unknown
Height/Dia	meter:	24x50	Ladder Gat	e: None	Ext. Lead: <u>Unknown</u>	Int. Lead: <u>Unknown</u>
YES	NO				·····

Whispering Pines Road West Tank

Whispering Pines Road East Tank

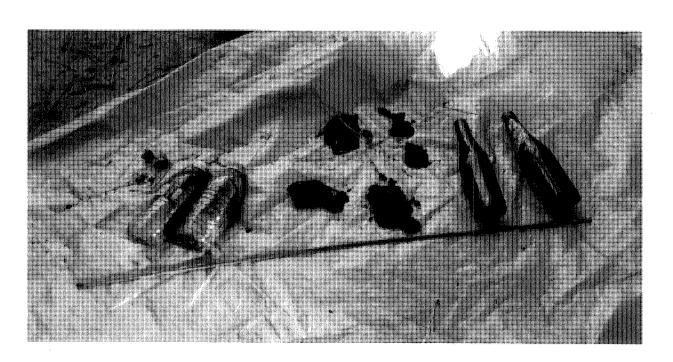
These are some of the item we found in the tank.

- 1. Lots of small rocks. 1" to 2" in diameter
- 2. Brass rod approximately 3' long.
- 3.2 beer bottles.
- 4. about a dozen hand sized pieces of rusty steel. Approximately

- 5. Approximately 40lbs of rust particles 1/4" and larger.
- 6. Debris on bottom of tank including sand, clay, rust, interior coatings buried from 4" to 8" thick
- 7. Some white in color biofilm on bottom of tank under 8" sediment.

Sunken roof due to collapsing rafters. Rafters not attached to dollar plate.
 Dollar plate is seriously failing due to extreme rust.

Exterior of tank needs recoating. Paint is almost completely gone.
 Paint thickness was about 1 to 2 mm with lots of rusty spot areas.

- 1. Note rust streak and water leaking from below man way.
- 2. Roof hatch needs a new seal.
- 3. welds, bolts, and rivet are fair.

1. rusty areas around entire tank and on roof area.

- 1. Exterior coating needs recoating.
- 2. Interior coating needs recoating.
- 3. Sunken roof due to collapsing rafters, from failed dollar plate.
- 4. No OSHA hand rails on top of tank.
- 5. No seal on hatch.

- 6. Exterior ladder is not OSHA approved.
- 7. No security lockout plate on ladder.
- 8. 2" hole in rodent screen on overflow assembly.
- 9. Target and float work but no water level indicators.
- 10. Some fire hazard with grass and brush near exterior electric connections.
- 11. No fence around entire area.
- In general, the entire area and tank need major renovation.
- As far as exterior paint and coatings they are long over due.

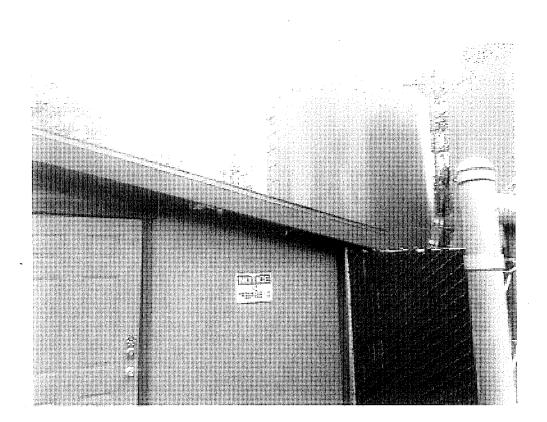
SUMMARY: Tank is in excellent condition

There is a leak in the general area. We did leak detection test and could not find the tank leaking.

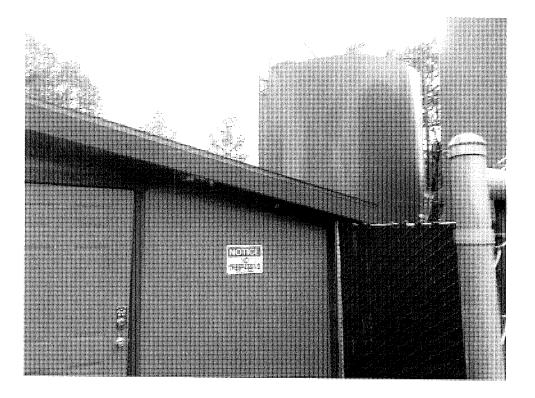
SUMMARY: Tank is in excellent condition

There is a leak in the general area. We did leak detection test and could not find the tank leaking.
