PINE-STRAWBERRY WATER IMPROVEMENT DISTRICT

PRELIMINARY ENGINEERING REPORT FOR WATER DISTRIBUTION SYSTEM IMPROVEMENTS

April 2019

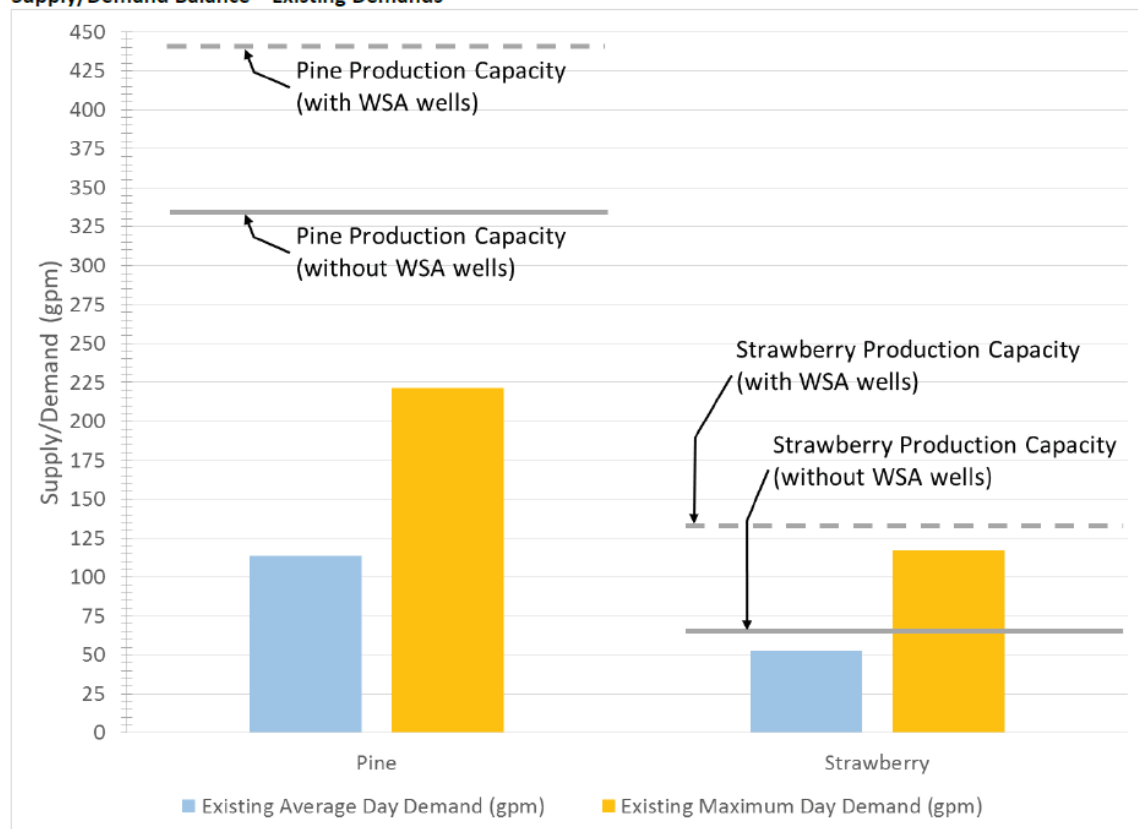
Figure 1.5

Supply/Demand Balance—Existing Demands

and at build-out to meet both the Average Day Demand (“ADD”) and the Maximum Day Demand (“MDD”). Strawberry has adequate supplies to meet ADD under existing and build-out demand scenarios and existing MDD if WSA wells are included. However, Strawberry does not have enough supply, even when considering use of WSA wells to meet MDD at build-out. Water systems should have enough supply to meet maximum day conditions to allow for storage tanks to refill during high demand months. PSWID has the flexibility to transfer water from Pine to Strawberry to make up for this shortfall using District-owned wells under existing conditions, but there is not enough supply available in Pine to continue this practice into the future without the use of WSA wells, or developing other sources of water such as the C.C. Cragin Reservoir water or new wells.

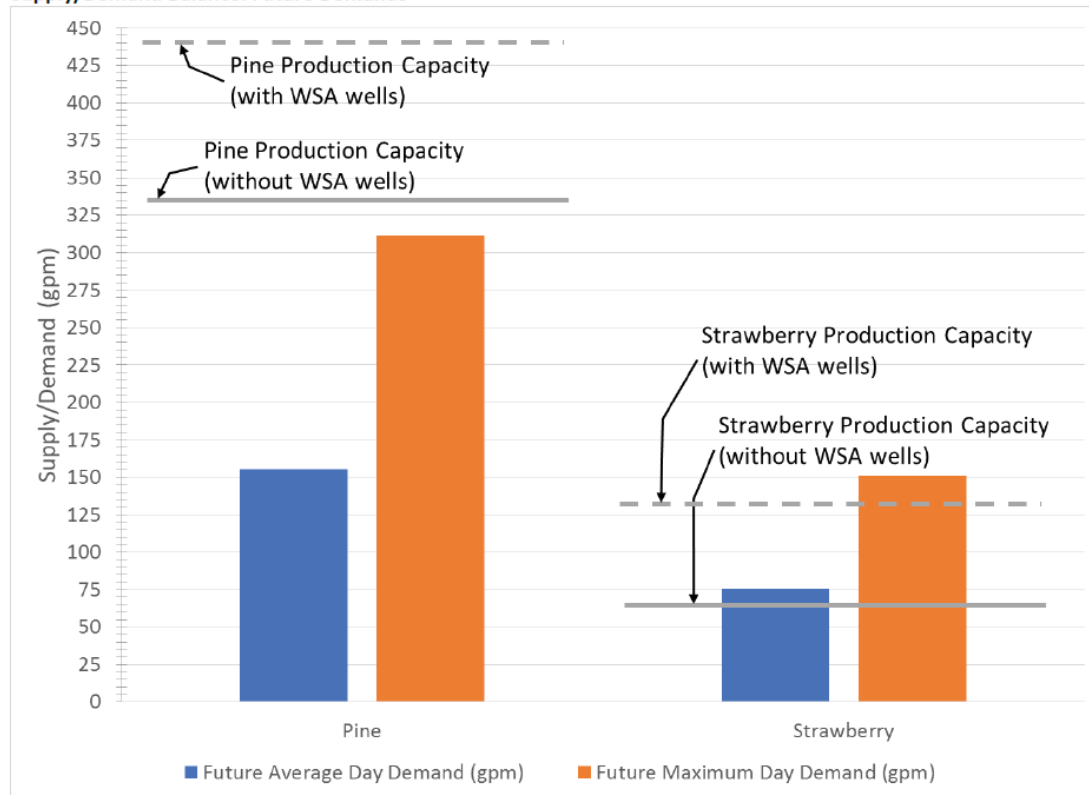
Figure 1.6

Supply/Demand Balance: Future Demands
